# Sale Vehicle Refurbishment

**Vehicle Registration:** LK10 EPX

### Condition

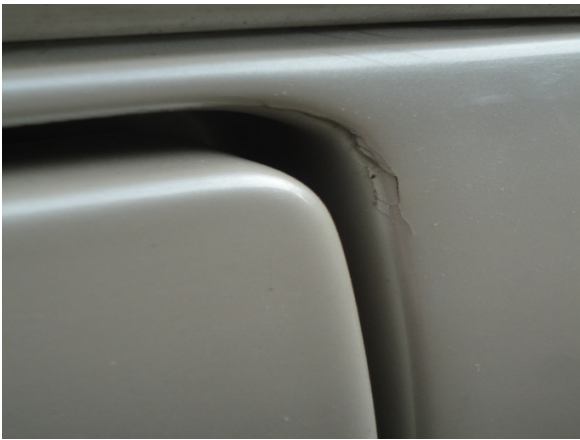
1. Crack RHS leisure battery skirt
2. Hairline cracks P/S middle skirt
3. Scratches LHS P/S rear wheel arch
4. Scratch P/S rear trim
5. Scratches on electrical hook up cover
6. Scuff in middle skirt rubber trim
7. Scratches in P/S front corner skirt
8. Ford sign peeling at edges
9. Trim on bathroom door frame has cracked and pieces missing
10. Dent D/S wall rear bed

1. Crack top RHS corner leisure batter skirt approximately 2 inches long
2. X6 hairline cracks in P/S middle skirt on LHS
3. Scratches LHS P/S rear wheel arch approximately 2.5 inches long
4. Scratch on the bottom of P/S rear trim approximately 1.5 inches long
5. Scratch on electrical hook up cover approximately 10 cm long
6. Scuff in middle skirt rubber trim approximately 10cm long
7. Scratches in front D/S corner skirt approximately 8cm long
8. Ford sign on front bumper peeling at edges
9. Trim on bottom of bathroom door frame has cracked and pieces missing
10. Slight dent in D/S fixed bed wall approximately 12cm long
